Schraube am Motor montiert

E4-01383A-01

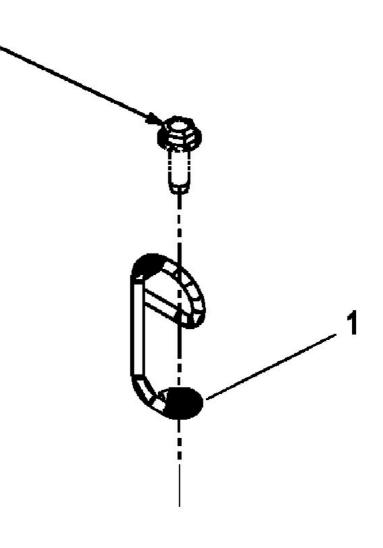
BOLT IS REMOVED FROM CORNER OF ENGINE HSG THEN REINSTALLED WITH THE CABLE GUIDE IN PLACE.
